Manhole Inspection Summary

Manhole # S35GG1001MH

Insp Date: **1/29/07 10:26 AM**

Location Address: **213 KEMBLE RD**

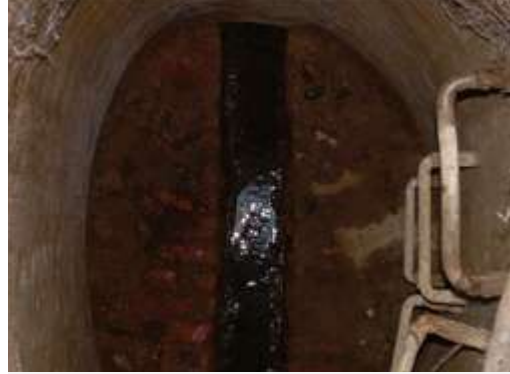
Top View

Corroded steps. Bench debris.

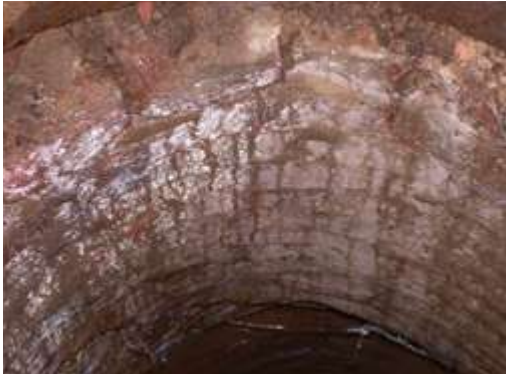
Defect

Frame leaks. Frame offset. Adjustment deterioration and infiltration. Barrel root intrusion and infiltration.

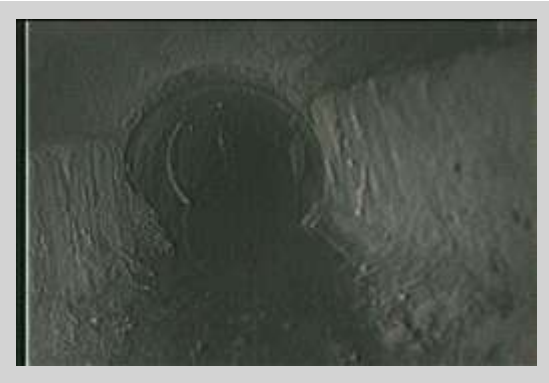
8 in. Circular Gravity Sewer Pipe Out @ 12 O'Clock

Deposits: ☐ None ☒ **Mud** ☐ **Grassy** ☒ **Debris** ☐ Grease

Silt Depth: **0.5** (in.) Deposits Extent: **Light**

Infiltration: **Evidence** Pipe Seal Cond: **Roots**

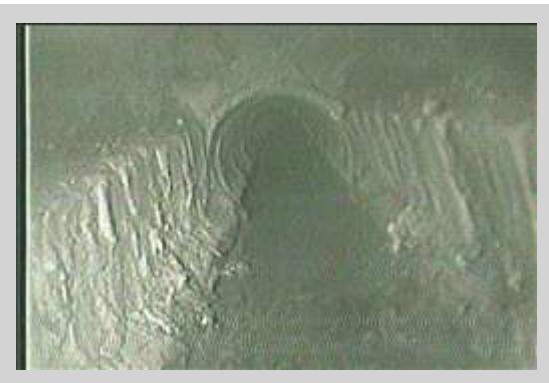
8 in. Circular Gravity Sewer Pipe In @ 6 O'Clock

Deposits: ☐ None ☐ Mud ☒ **Grassy** ☒ **Debris** ☐ Grease

Silt Depth: **0.5** (in.) Deposits Extent: **Light**

Infiltration: **None** Pipe Seal Cond: **Cracked**
